**DRAFT VAPOR INTRUSION MITIGATION
INSTALLATION REPORT
4TH AND GAMBELL
ANCHORAGE, ALASKA**

DECEMBER 5, 2014

**Environmental Quality Management, Inc.
18939 120th Avenue NE, Suite 103
Bothell, Washington 98011**

**Ahtna Engineering Services, LLC
110 West 38th Avenue, Suite 200A
Anchorage, Alaska 99503**

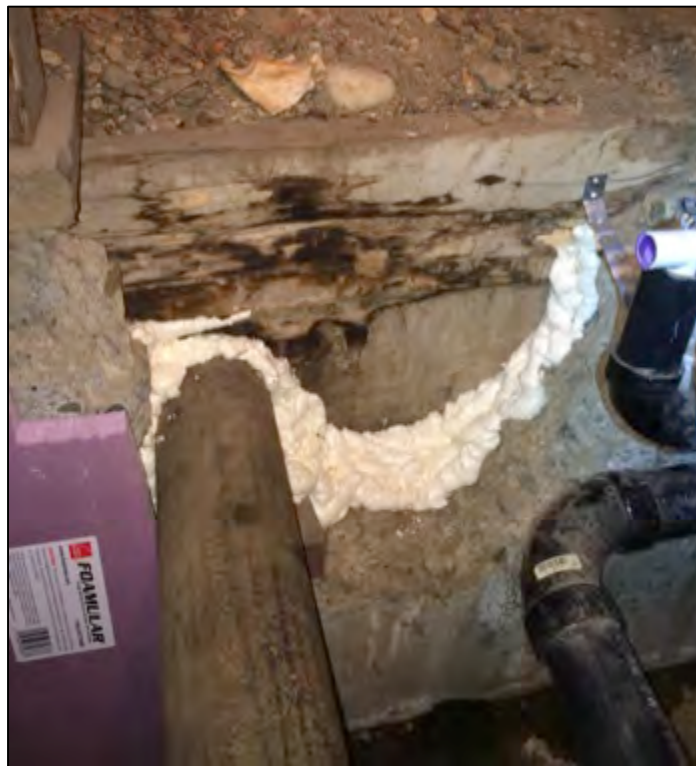
Photograph 2: Patched cracks in foundation in advance of applying vapor barrier paint.

Multiple voids, cracks and holes were sealed in the concrete slab and foundation walls with concrete patching materials or caulking as necessary to minimize potential pathways for vapor leakage into the building. Significant sealing was performed around the above grade sewer line in the basement area where the ends penetrate the concrete slab and foundation wall.

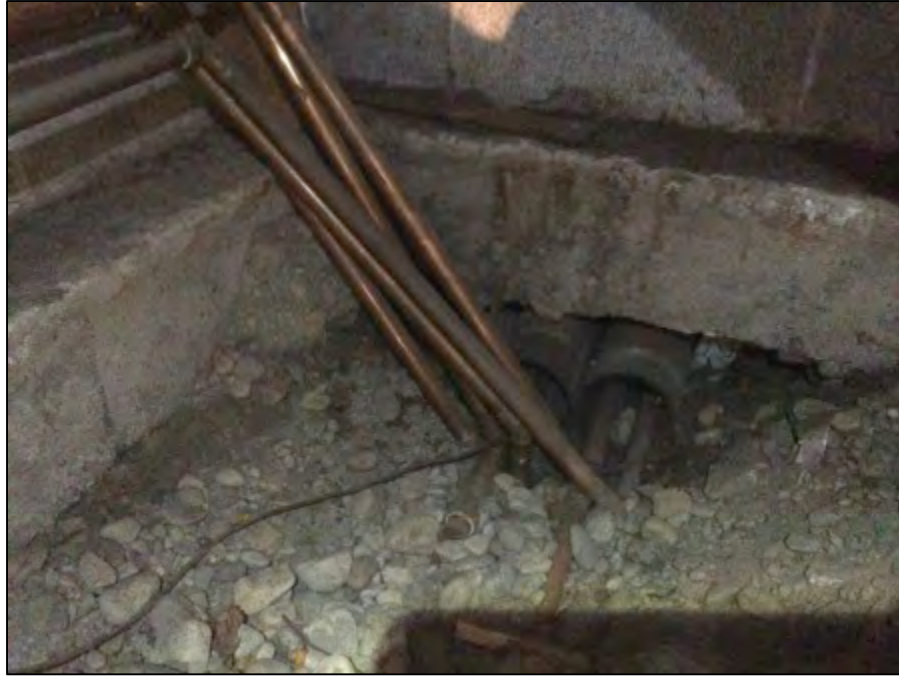
An approximately 4-inch diameter plastic conduit pipe, containing multiple copper water lines, was discovered extending through the foundation wall towards the South Duplex. The building manager confirmed that the water heater, located in the basement of the North Duplex, services both buildings and that both buildings share a common cold water supply. In addition to the operational water lines, two open-ended and disconnected water lines extended between the two. No insulation or packing material was observed in the conduit to obstruct airflow between the crawlspaces of the two duplexes. Ahtna sealed the conduit and the disconnected water lines with spray foam insulation to eliminate the potential vapor migration pathway between the two buildings.

Photograph 3: Water lines extending through buried conduit piping between the North and South Duplexes at 736 East 3rd Avenue.

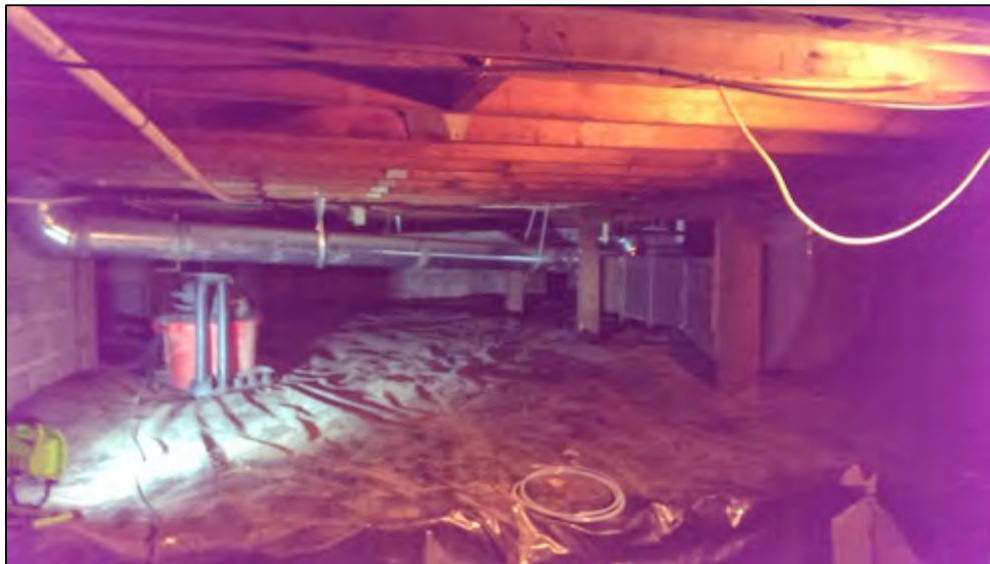
Photograph 4: Cleaning and removing old vapor barrier material in the North Duplex.

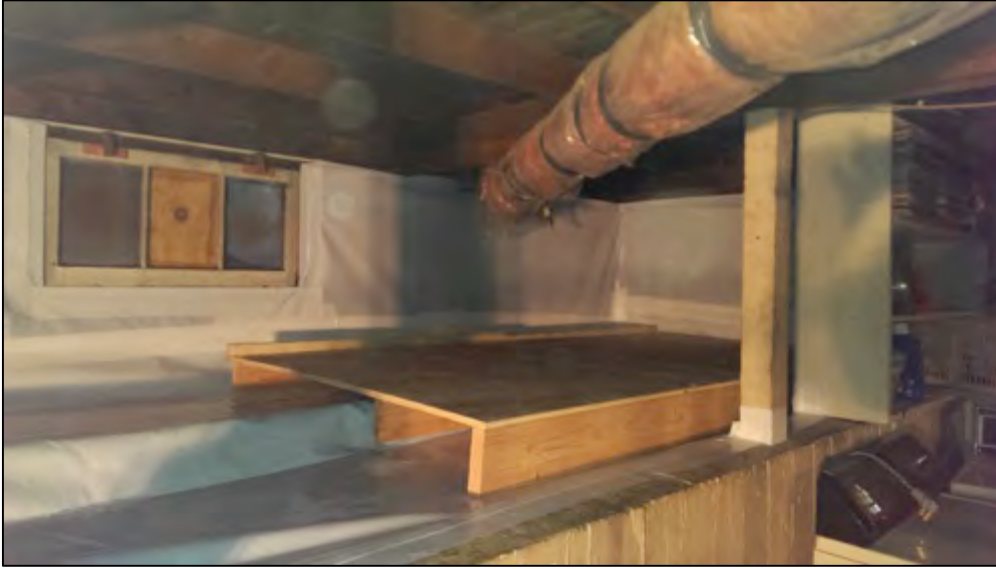
Photograph 13: Wooden platforms installed over the vapor barrier and perforated piping to provide storage space while protecting the liner.

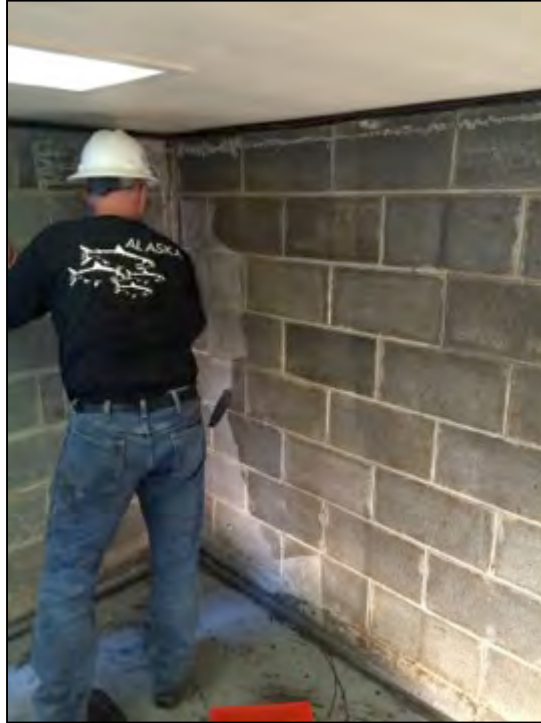
Photograph 19: Applying Retro-Coat™ vapor barrier primer on the concrete walls of the North Duplex.

Migration of contaminants vertically through the concrete slab and laterally through the concrete foundation walls was mitigated by sealing the surfaces with the vapor intrusion coating system, Retro-Coat™, by Land Science Technologies™. The Retro-Coat™ coating was applied along the concrete slab and concrete foundation walls of the North Duplex.

PetroChem, an installation company certified by Land Science Technologies™, prepared the surfaces and applied the Retro-Coat™. The installers prepped the surfaces by sanding and grinding the surfaces smooth. The floor was ground to a CSP-3 concrete surface profile using a grinder with a diamond wheel. The block walls were sanded by hand to remove loose mortar or concrete. Cracks in the floor were routed out with a grinding wheel to provide a groove where grout could be applied. The surfaces were thoroughly cleaned using a HEPA vacuum and wet cloths. Cracks, floor penetrations, and around utilities were sealed with an epoxy-based grout. The walls and floors were then painted with a primer coat that ensures proper adhesion of the Retro-Coat™ to the concrete. Two coats of Retro-Coat™ were applied to the floor and walls. All remaining seams and cracks were then sealed with a vapor-tight caulk that matched the color of the Retro-Coat™ product. Additional information on the Retro-Coat™ product is included in Appendix C.

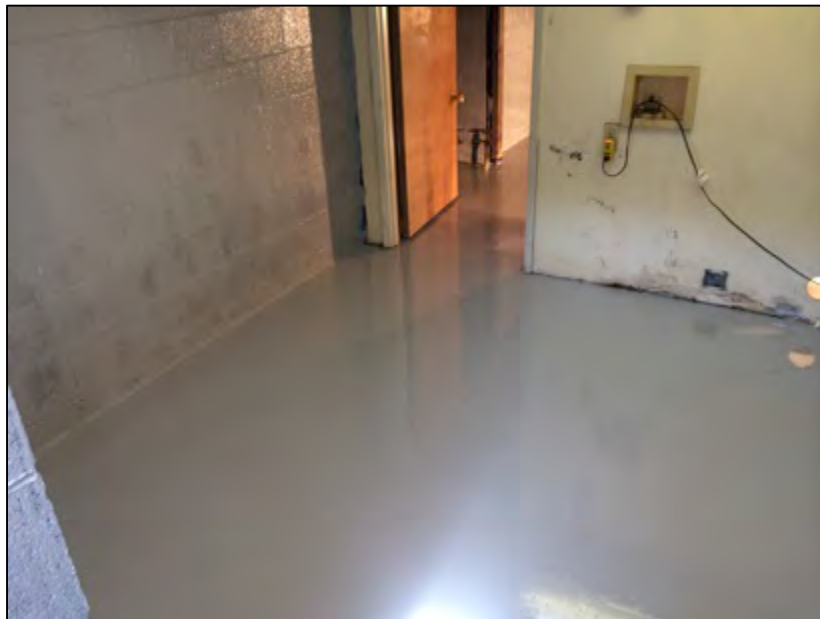
Photograph 20: Completed application of Retro-Coat™ on the concrete floor and walls in the North Duplex.

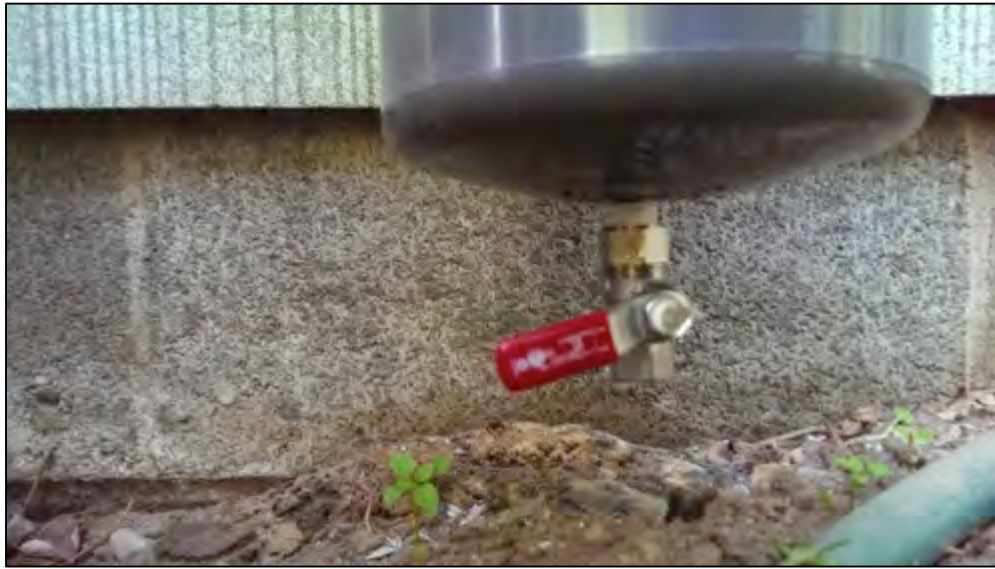
Photograph 27: Image of the condensate drain valve at the base of the exhaust stacks.

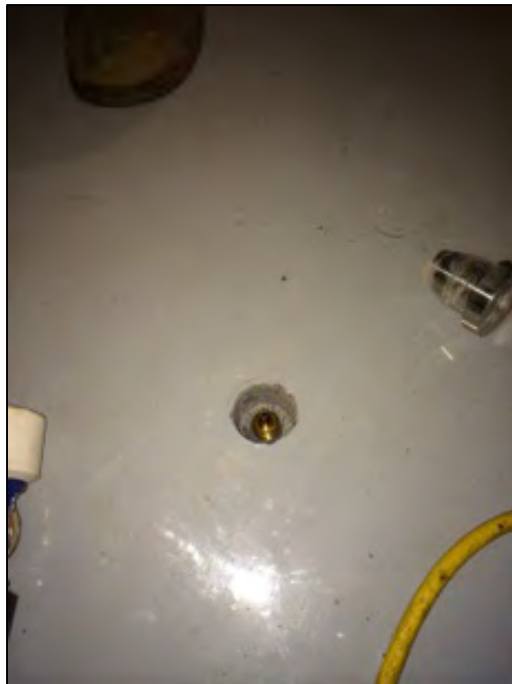
Two VMPs were installed through the concrete slab in the basement. The locations of the VMPs are shown on Figure 5. The VMPs are constructed of a 1/4-inch brass Vapor Pins with locking stainless steel covers. The top of the Vapor Pin is recessed below the top of the concrete slab to prevent damage and tripping.

Photograph 30: Sub-slab vapor monitoring point in the concrete floor of the North Duplex building.
